Manhole Inspection Summary

Manhole # S17M__008MH

Location Address: **2401 ashton-frederick shopping center** Cross Street: **s catherine**

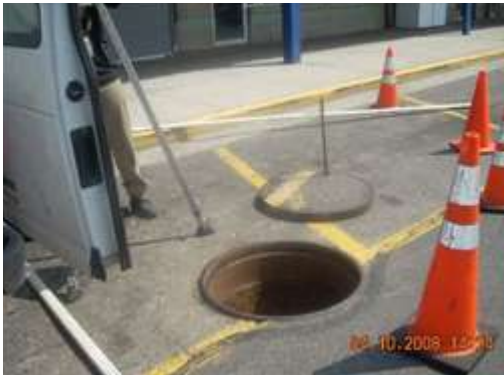
Location View

Comments **located infront of gamestop in the firelane**

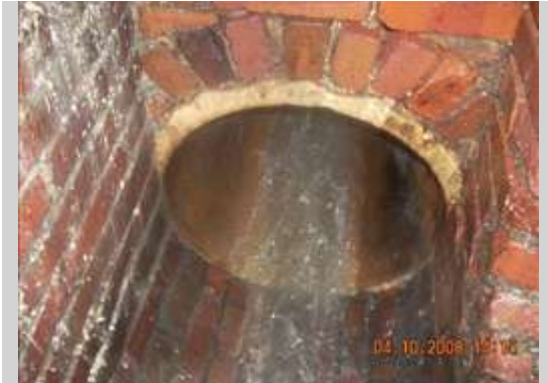
12 O'Clock Outflow

21 in. Circular Gravity Sewer
Pipe Out @ 12 O'Clock

Pipe Height: **21.6** (in.) Rod and Bar (Angled)
Pipe Material: **Clay** ☐ Pipe Lined
Invert Depth: **27.45** (ft.) Flow Characteristics: **Fast**
Deposits: ☒ None ☐ Mud ☐ Sludge ☐ Debris ☐ Grease
Silt Depth: **0** (in.) Deposits Extent:
Infiltration: **None** Pipe Seal Cond: **Sound**
